Evaluation of the Sragi Secondary Channel of the Kaliwadas Irrigation Area, Pekalongan Regency

Abstract: The Sragi secondary channel is located in the Kaliwadas irrigation area, Pekalongan Regency has a length of 7,587 m. The position of the channel is in a rice field area which is used to optimize irrigation to support agricultural business productivity. The existing condition of the channel in the form of native soil causes frequent leaks. Technical handling is needed to repair irrigation buildings in the form of a study on the existing condition of the Sragi secondary channel through field surveys and checking physical conditions. Furthermore, identification of the level of damage to irrigation channels is carried out. From the problems that arise at the identification stage, recommendations are then given in the form of proposals for improvements to buildings and irrigation channels. The results of the field survey in the form of network tracing provide data that the level of physical and functional damage to the Sragi secondary channel infrastructure reaches >40%. The condition is categorized as very bad with the classification of severely damaged which requires repair or rep

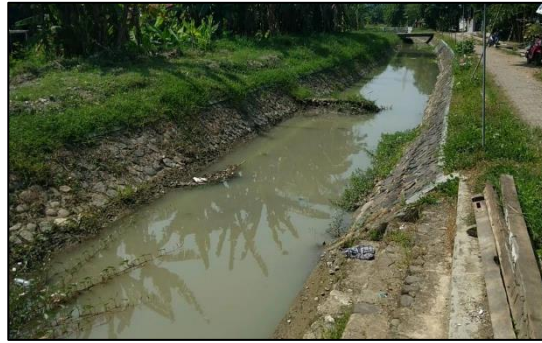
Fig. 2. Existing Condition Hm 00+00

No	Location	Length (m)	Existing condition
1	Hm 50+00 to 50+75	75	The right side lining is made of precast concrete measuring 40cm x 80cm x 0.6m with localized damages.
2	Hm 50+00 to 52+82	282	The right side lining is made of stone masonry with localized damages.
3	Hm 57+57 to 60+50	293	Both the right and left side linings are made of precast concrete measuring 40cm x 80cm x 0.6cm with localized damages.
4	Hm 62+00 to 64+20	220	The left side parapet made of stone masonry is still in good condition. From Hm 63+35 to 63+50 (15 m), the parapet made of stone masonry is damaged.

No	Location	Length (m)	Existing Condition	Recommendation for Improvements
1	Hm 50+00 s.d 50+75	75	Left-side stone masonry lining is damaged	Repairs with precast concrete K-300
2	Hm 50+00 s.d 52+82	282	Right-side stone masonry lining is damaged in spots	Replace damaged old stone masonry with a stone masonry 1 : 4

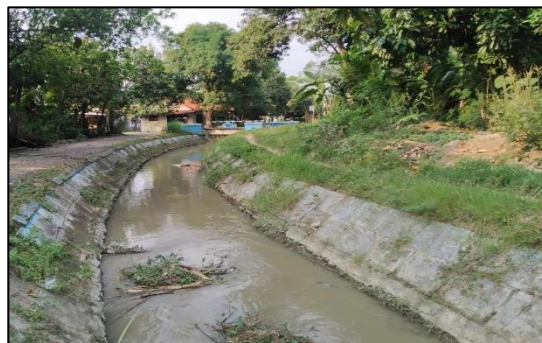
Fig. 5. Existing Condition Hm 71+00

No	Location	Length (m)	Existing condition
5	Hm 64+20 to 65+31	111	Both the right and left side linings made of precast concrete have localized damages.
6	Hm 66+25 to 67+97	172	The right side lining made of precast concrete is still in good condition. The left side lining made of precast concrete has localized damages.
7	Hm 71+00 to 75+68	468	Both the right and left side linings of the existing precast concrete are still good.

10	Hm 66+25 s.d 67+97	172	The left-side precast concrete lining is damage	Repairs with precast concrete K-300
11	Hm 71+00 s.d 75+68	468	Both left and right precast concrete linings are still in good condition	Maintain the old precast concrete
