The Impact of Alluvial Land Subsidence Towards Extension of Inundation and Infrastructure Damage At Settlements Around Harbor Area of Tanjung Mas – Semarang

Soedarsono

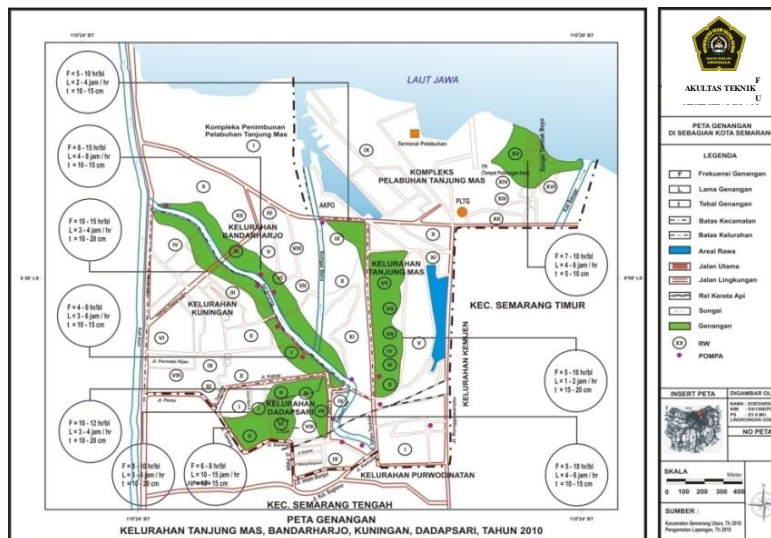
Figure 02 Inundation Map in 1996

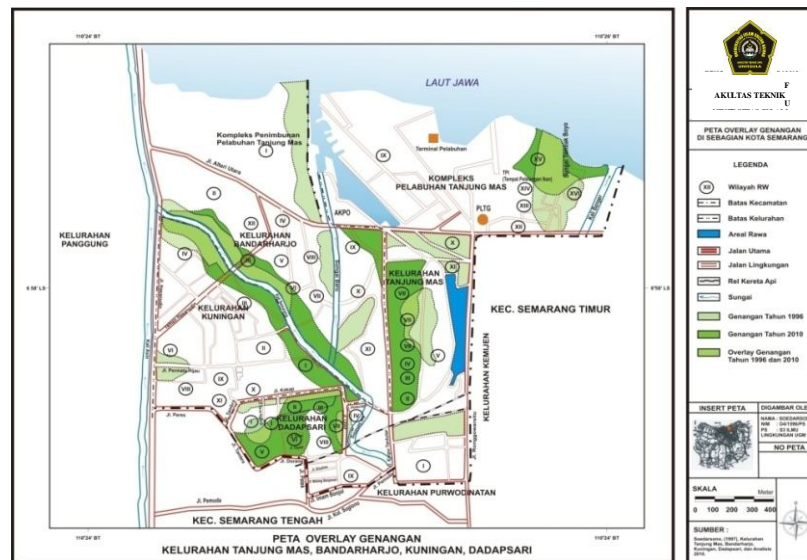
Based on the figure 02 and table 01, this can be understood that during 14 years, there was increase of inundation in the four villages of 29.62 hectare with extension generally on the right and left side of Semarang River, on the edge of the drainage systems and at the settlement having low topography. The change of inundation in the four villages (research location) in 1996 and in 2010. This can be seen from figure 03.

Figure 3. Map of Inundation Change in 2010

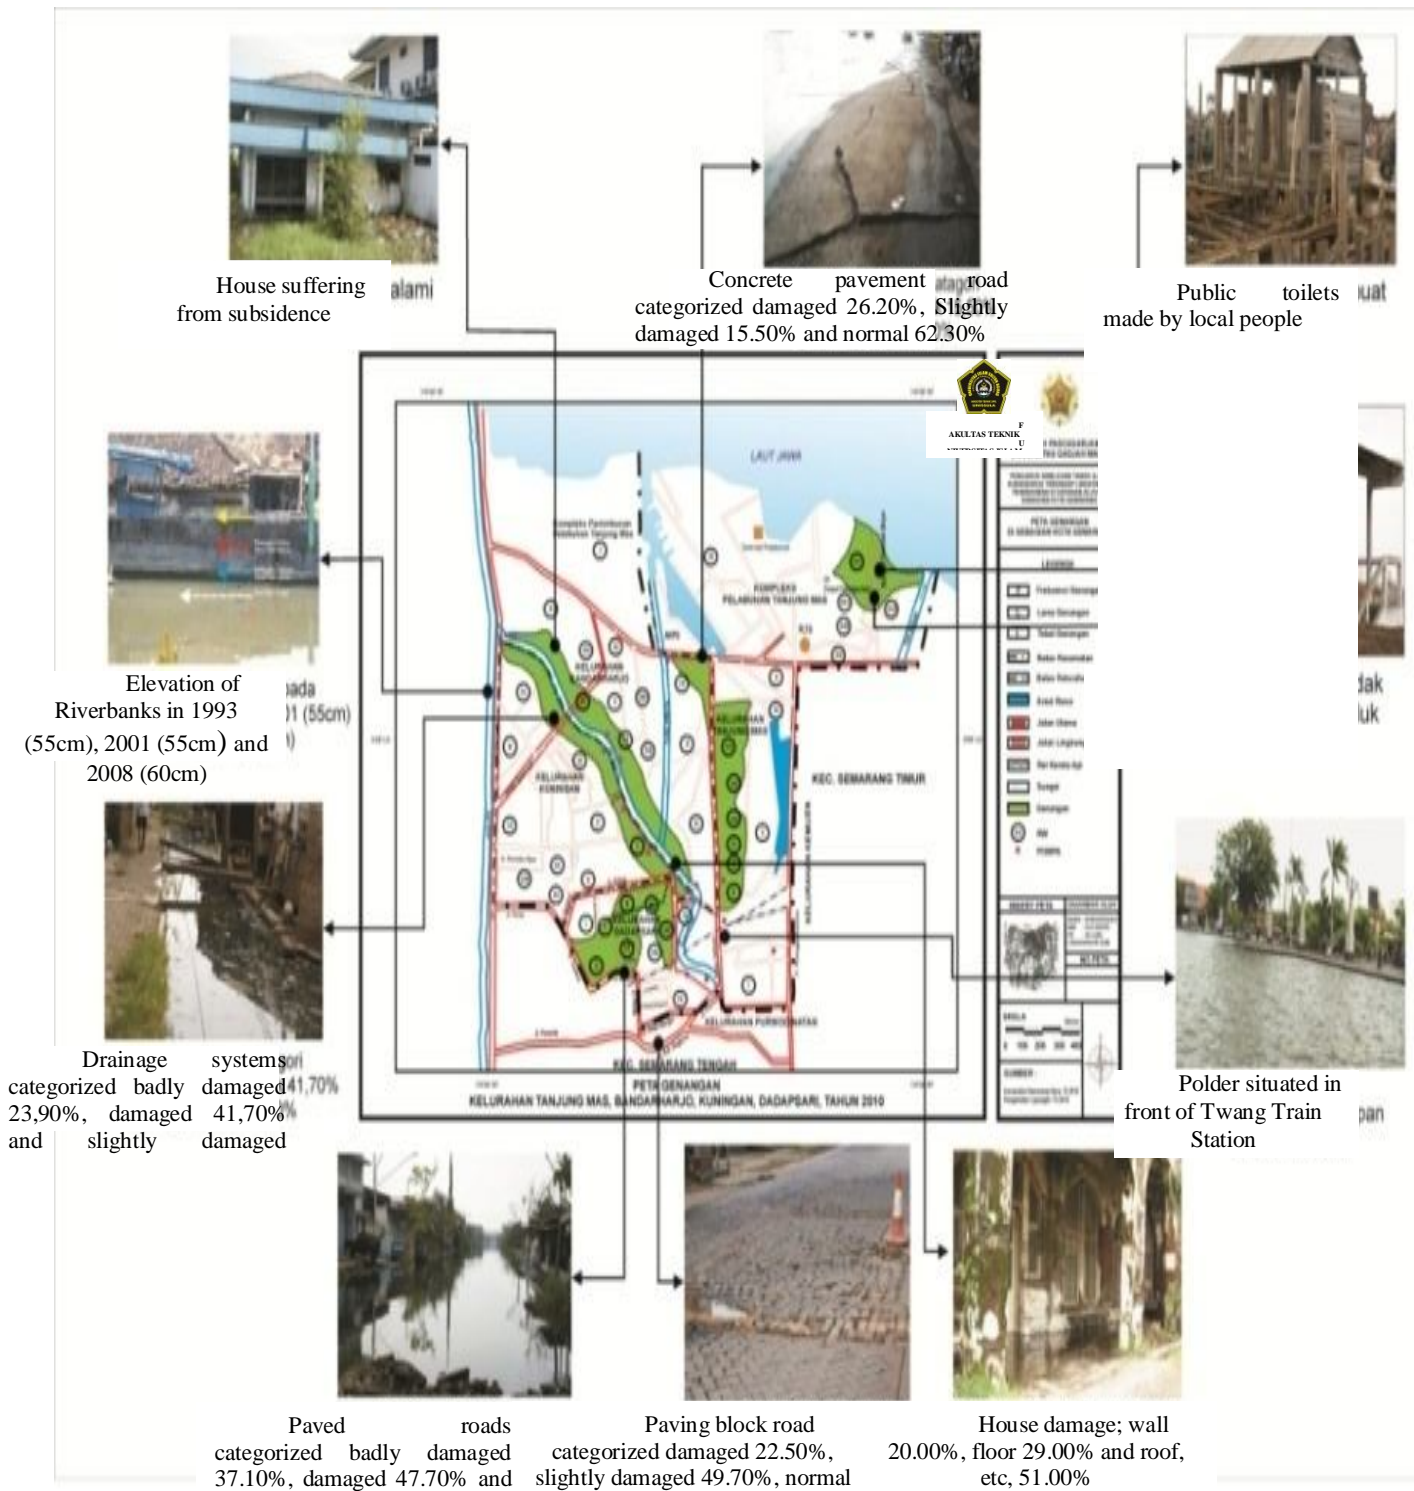
Figure 4. condition, house location and infrastructure suffering from damage due to inundation at the settlement in 2010

Prabowo (2009) conducted research using mixed design of thin layer of asphalt concrete of worn-out layers, explained the higher acidity of the water and the longer being submerged in sea water, the faster it would be peeling the asphalt mixture. Road damage with asphalt pavement happening in Jl. Dorang, Jl. Tombo and Jl. Empu Tantular were much caused by sea water immersion.

Damage of road construction with concrete layer in Jl. Usman Janatin was the impact of structure damage, such as cracks on the pavement layers (upper layer), but did not happen to the basic of *slab* concrete. Road damage with concrete pavement layer in Jl. Usman Janatin in the area of Tanjung Mas was mostly caused tender basic soil layer due to being submerged by water and the road itself was frequently passed by heavy leaden vehicle. Road damage with pavement lalyer *paving block* was caused by discharge of the lower sand layer *paving*

block because of the water submerging, displacement of sand under the pavement (*bedding sand*) caused instable road layers (Hatta et.al, 2003). Road damage in Jl. Layr and Jl. Kolonel Sugiono using paving block, besides it was frequently submerged, this was also because of heavy leaden vehicle passing by.

The condition of drainage system in the research location was partly broken in the left and right side of the channel, most of which were full of sediment and household waste, existing drainage systems were turning following condition of the settlement with the slope (*i*) lesser than 2%, as a result while raining and high tide, the water would flood the settlement.

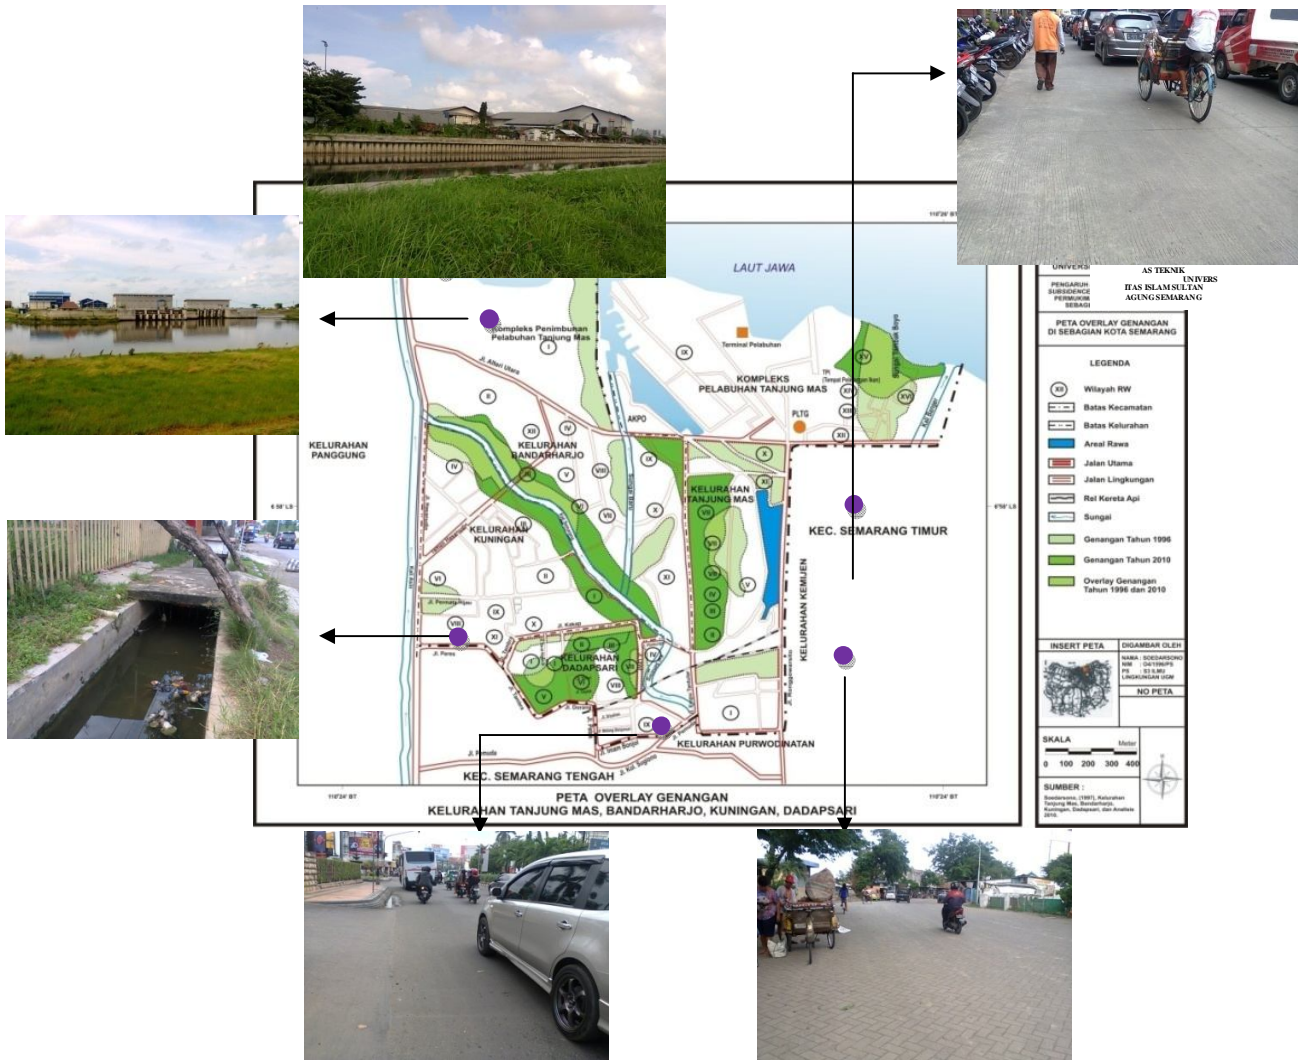
Figure 05 Condition, house location, and infrastructure sufferin from damage due to inunation at the settlement in 2015

In 2015, there were two kinds of events happened, first was the inundation decreased of 68.44 hectare and second, the decrease of infrastructure damage of the settlement due to normalisation happening to Semarang and Asin River, by sediment dredging to those two rivers as well as improvement of the estuary the water could flow well, besides, this was the first time for Semarang River restensive pool to be operated, as a result, when high tide was happening the door of restensive pool was closed to which this was able to partly block the sea water coming to the River.
