# ROAD DAMAGED FACTOR ANALYSIS AT SIGNALIZED INTERSECTION

## (Case Study: The Traffic Light in Front of UNISSULA, Jl. Raya Kaligawe KM 4, Semarang)

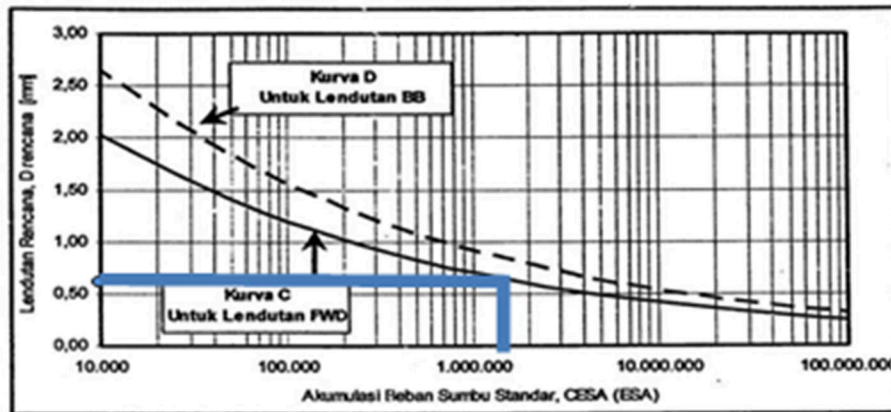
Figure 1. The Connection Between Plan Deflection and Traffic

The planned deflection was determined at 0.70 mm, based on Figure 1 above. After the values of planned deflection were obtained, they are presented as the following Figure 2.

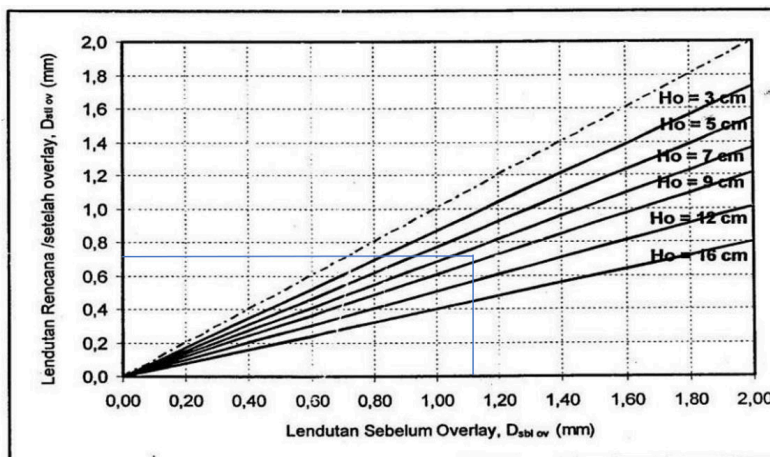
Figure 2. Overlay

Figure 2 shows that the required overlay thickness amounted to 10.9 cm. In accordance with the table of design and construction of asphalt pavement 02/M/BM/ 2013,

the overlay thickness used was 11 cm, with AC-WC thickness at 4 cm, AC-BC thickness at 7 cm, minimum allowable AC-WC wear layer at 4 cm, and allowable thickness between AC-BC at 6 cm.
