## **Experimental Study of RC Hollow Beams with Embedded PVC Pipes**

**Abstract:** This study investigated the behaviour of reinforced concrete (RC) hollow beams under incremental static loads. Polyvinyl Chloride (PVC) pipes were used to create longitudinal voids in hollow beams. The parameters studied included the size (25 mm, 50 mm and 75 mm diameter) and location (39 mm and 139 mm from beam soffit) of the PVC pipes in the beam. Nine specimens were tested under the four-point load test setup. The loads were progressively increased until the specimens failed. The specimens were analysed based on the failure modes, load-displacement responses and mechanical properties. The hollow beams gave a 2% to 36% lower strength than the solid beams. In terms of the strength per unit concrete, the hollow beams were less efficient than the solid beams. The efficiency ratio of hollow beams ranged from 0.67 to 1.0. For that, none of the proposed hollow beams was recommended.

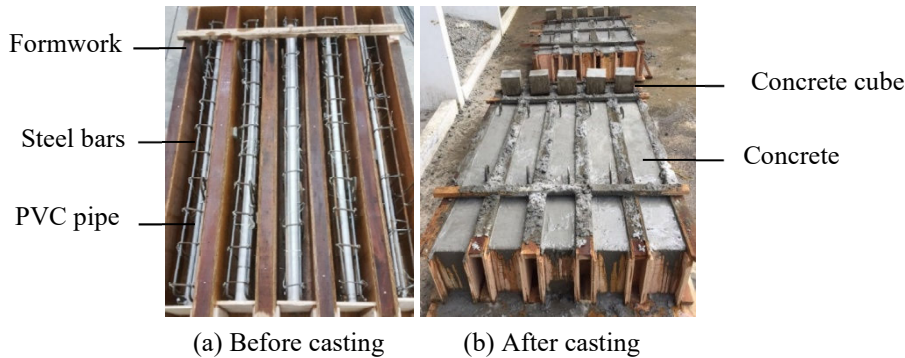
**Fig. 4.** Fabrication of beam specimens.

The specimens were horizontally cast in plywood moulds using ready-mixed concrete grade 25 (Fig. 4). The maximum aggregate size was 20 mm. The slump was designed in the range of 60 mm to 180 mm. The specimens were cured by preserving water on the beam top surface for at least 7 days. The specimens were placed in an open-air area which was sheltered. The atmosphere temperature was 30 ± 5°C. The specimens were tested after 28 days of casting.
