Bond-shear Behavior of FRP Rods as a Function of Attachment Configuration

Agung Budipriyanto¹, Ay Lie Han^{2*} and Hsuan-Teh Hu³

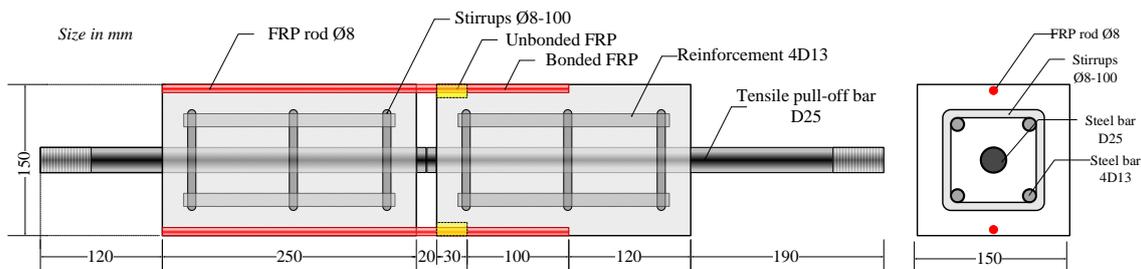
The test set up was designed based on the previous tests on FRP sheets [10]. This direct tensile testing method is widely used to investigate the strength and failure mechanism of bond [11-14]. The aim of the research was to determine the ultimate failure load of a symmetrical assemblage of two rods attached to two concrete blocks (Fig. 1).

Fig. 1. Experimental test set up for FRP rod bond behavior

Based on the assumption that the bond of FRP rods closely approaches the bond of identical sized steel reinforcing bars, the set-up was designed so that the bonded FRP rod will fail due to bond loss. The designed bond-length was set to 100 mm. To anticipate the high-stress concentration in the edges of the concrete specimens, a plastic tube was used to prevent the unbonded part of the FRP rod, measuring 30 mm, to bond to the concrete. Test results on the effect of FRP rod bond-lengths were conducted by Caro et al. (2017) [15], the bond-length was found to be one of the significant factors influencing the failure mode.

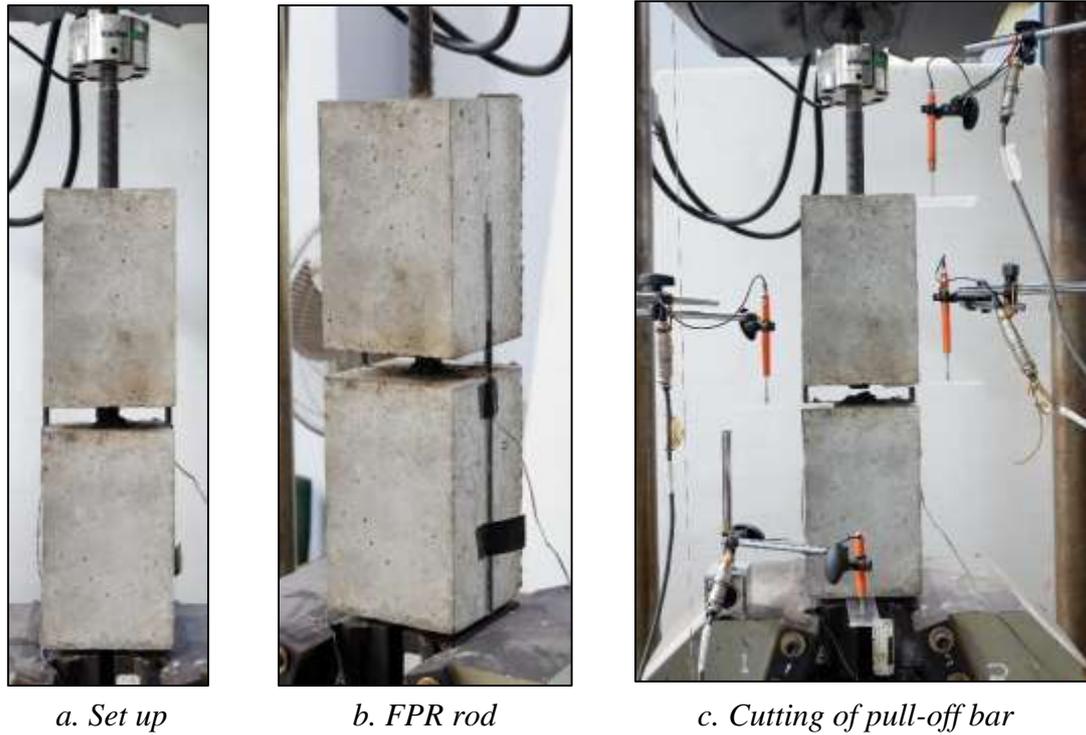
During casting, the tensile pull-off bar with a diameter of 25 mm was arranged as one solid element. This method would ensure that the test specimen is stable, and the applied tensile force was centric (Fig 2a and Fig 2b). When the grips of the universal testing machine (UTM) were securely set, the pull-off bar was cut, and precision instruments were placed (fig 2c). The UTM applied a centric tensile load to the 25 mm bars; the increment load was set at 20 N/sec. The bonded FRS rods were closely observed during the monotonic increment loading.

Fig. 2. Assemblage and pull-off bar cutting

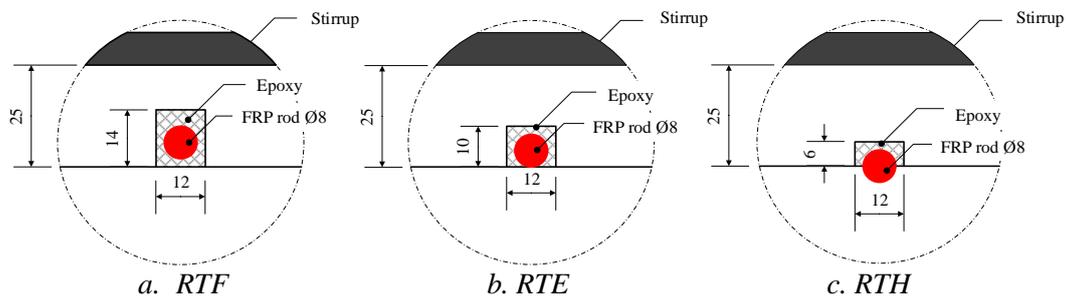
The embedded depth of the rods influences the bond between the rod and the epoxy resin, and the epoxy resin to the concrete. The relative position of the rods to the concrete surface also affects the stress distribution in the concrete. The larger stresses are induced near the end of the rod, as a result of an accumulation of strains during the tensile test [16]. The probable failure modes are concrete failure in shear, bond loss in the interface between the concrete and the epoxy, or the failure in the interface between the rod and the epoxy. The failure of the FRP rod in tension was not considered in the experiment since the very high tensile strength of the material. The position of the FRP rods relative to the concrete surface were distinguished into three types (Fig 3a, 3b and 3c).

Fig. 3. Specimen classification

Specimens RTF that are applied in accordance to the ACI 440 code [17], had an embedded depth of 14 mm. This code mandates a depth of at least 1.5 of the rod diameter. Specimens RTE had a contact area of 75% with a groove depth of 10 mm while specimens RTH had an interface of one-half the rod circumference, with a groove measuring 6 mm in depth. For each category, four (4) specimens were prepared.

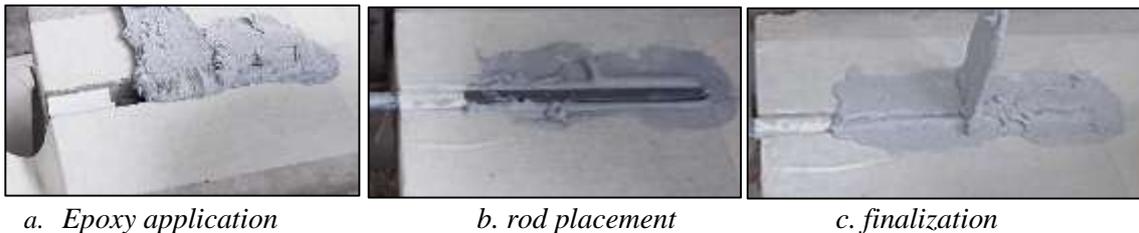
The concrete specimens were moist cured for 25 days. A groove was prepared on opposite sides of the concrete block using a diamond, water cooled saw. The block was dried and the groove securely cleaned from all remaining cement debris with a sandblast, and filled with the epoxy (Fig 4a). The position of the rods was carefully monitored to ensure that its arrangement was in accordance to the design (Fig. 4b). Finally, a layer of epoxy was attached to seal the gaps between the rod and the epoxy (Fig. 4c).

Fig. 4. Rod assembling

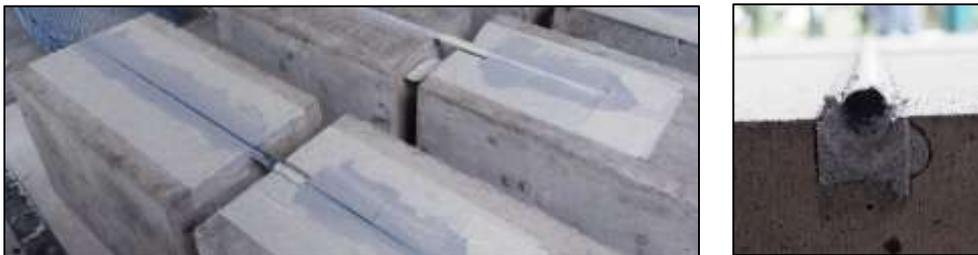
The RTH specimen was only filled on both sides of the rod. The attachment of the epoxy to the rod was prevented by covering the half rod with a duct tape (Fig. 5).

Fig. 5. RTH assemblage

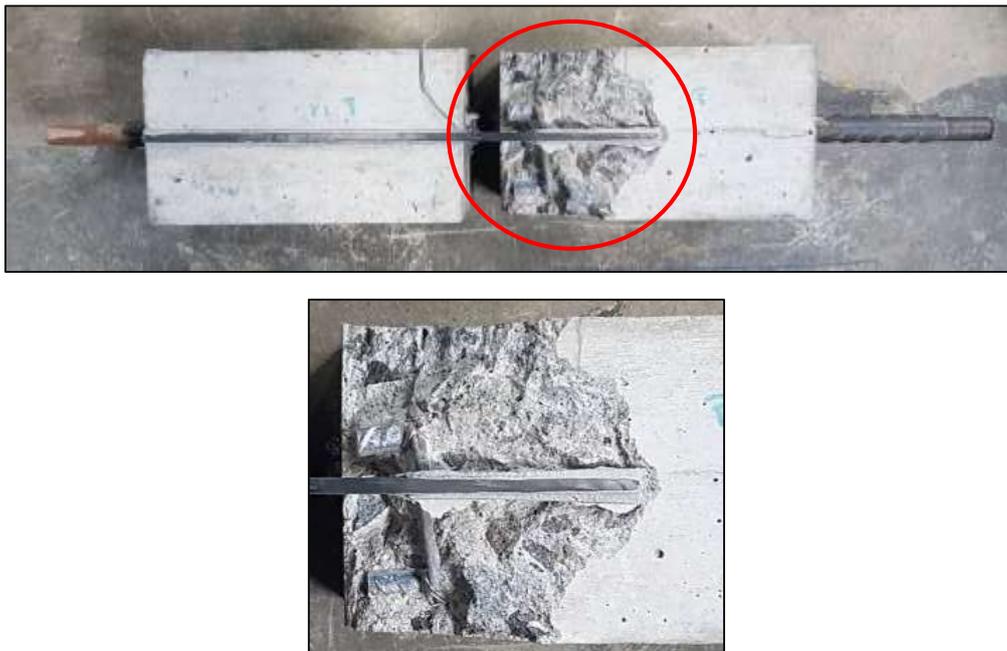
Specimens RTH₁ and RTH₃ failed due to concrete fracture in shear, as can be seen in Fig 6. The stress in the concrete at failure was calculated to be 2.4 MPa, this could be assumed being the shear strength of the concrete at fracture.

Fig. 6. Concrete failure in specimens RTH

The specimen type RTH had an embedment depth of 6 mm. The specimens' failure modes were distinguished by bond failure between the rod and the epoxy, and concrete failure. No eccentric loading was observed during the process, and all the specimens failed in the shorter part of the attached FRP rod. Table 1 shows the recorded loads at ultimate and the stress in the corresponding failure area. The interface area between the rod and the epoxy was taken as $A=\pi r l$ [11,13], where r is the rod radius equal 4 mm, and l is the bond length of the bonded rod measuring 100mm. As for the concrete failure, the angle of fracture was measured to be approximately 23° . The failure surface was taken as a half cone with a height of $l+30$.

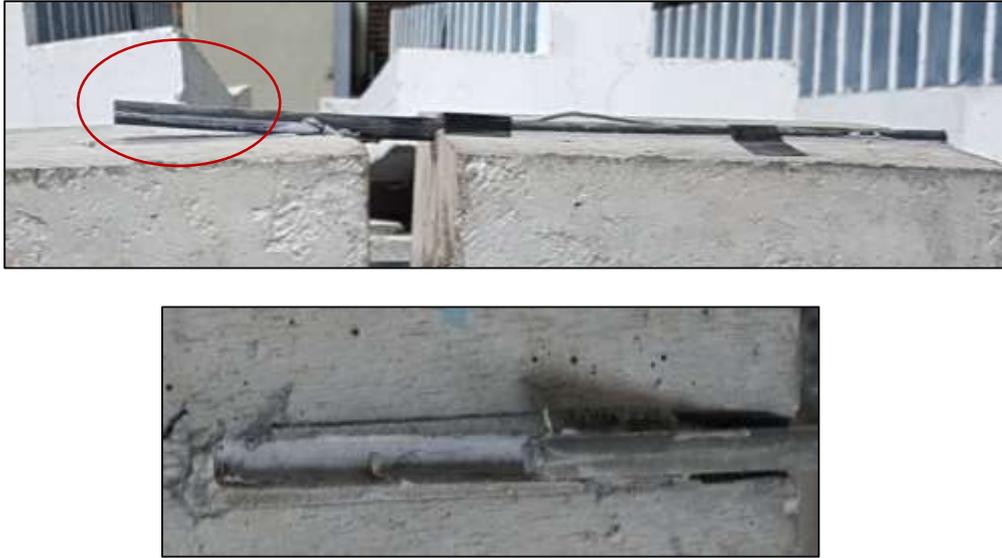
Specimens RTH₂ and RTH₄ failed due to bond loss in the interface between the rod and the epoxy. The very limited contact area of only one-half of the rod, drastically increased the stresses in the interface. As seen in Fig. 7, at failure the stresses in this area measured up to 16 MPa (Fig. 7). The bond between the epoxy and concrete, however remained intact.

Fig. 7. ITZ bond loss in specimens RTH

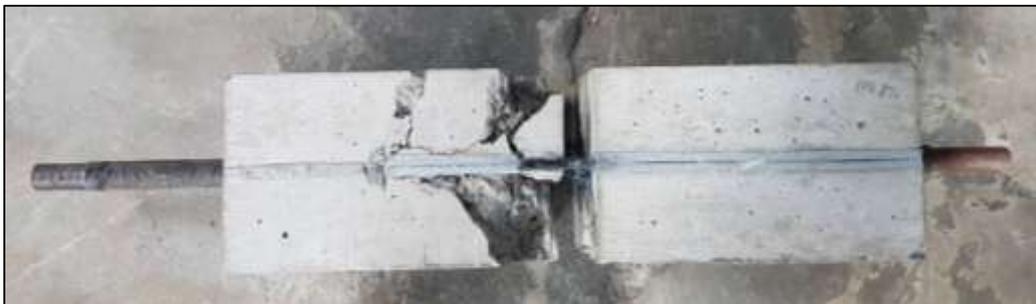
The shifting from the edge position of the rod to the center of the groove didn't significantly increase the shear strength. Fig. 8 represents the failure pattern of both RTE and RTF.

Fig 8. Concrete failure pattern of RTE and RTF

The failure mode of all RTF specimens was identical to the RTE specimens. The failure was unmistakable in the concrete area. Underlining the previous conclusion on the increase in bond strength upon fracture, it was also shown that the shear strength at failure was slightly higher when compared to the RTE specimens. The average shear strength was calculated as 2.8 MPa. Table 3 represents the results.

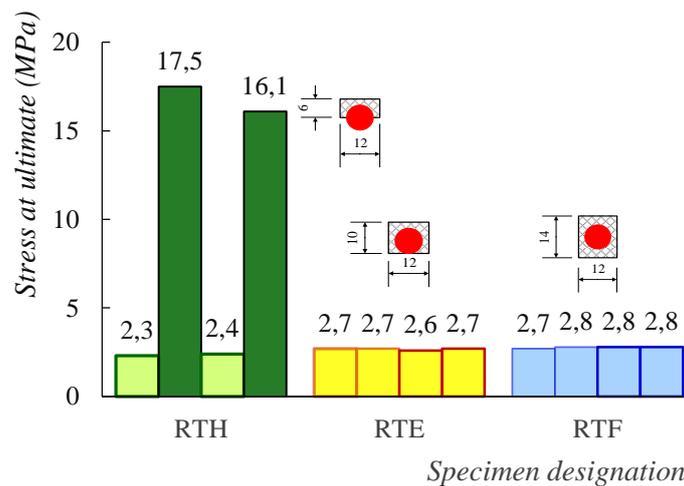
Fig. 9 graphically represents the stresses at failure for all three categories. The specimens that failed in the ITZ bond have a very high stress level due to the small area of the interface.

Fig 9. Failure stresses comparison

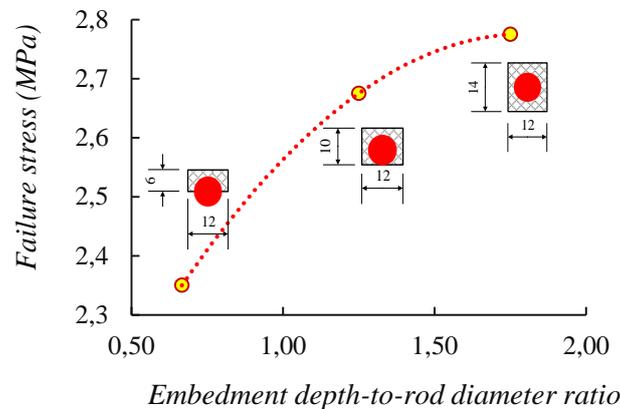
To evaluate the effect of embedment depth to the stresses in the concrete at failure, the average strengths were plotted against the embedment-to-rod diameter ratio, as can be seen in Fig. 10.

Fig 10. Rate of stress increase as a function of embedded rod depth

The increase rate followed a parabolic, convex path, suggesting that a convergent state exist. The increase is more pronounced when the rod's position is shifted from the outer concrete layers when compared to the arrangement inside the concrete itself. This result suggested that placing the rod deviating from the codes could still provide a good bond, and the assembling of these rods could be optimized.

All full embedded rods, including the type where the rod was placed parallel the concrete surface, resulted in concrete shear failure. The stresses at ultimate increased, as a function of embedment depth, suggesting that the thicker the concrete cover, the higher the shear strength of concrete becomes. This enhancement is most probably originated from the better density of the concrete, farther away from the surface layers, and the strain in the direction perpendicular to the load-strain, resulting in confinement in compression.
