EVALUATION OF THE QUALITY OF PHYSICAL ASSETS BATU MAHPAR GEOPARK RECREATION PARK IN TASIKMALAYA DISTRICT

Keywords: Quality, Physical Asset, Batu Mahpar, Geopark Recreation Park

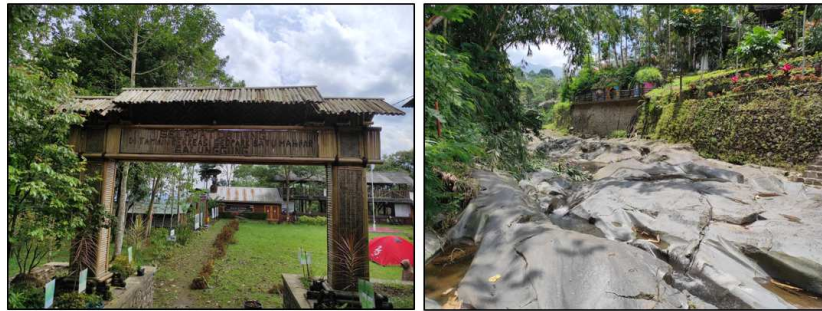
Figure 1. *Batu Mahpar Geopark Recreational Park*
Source: Compilers, 2022

diversity, biodiversity, and cultural diversity (Regulation of the President of the Republic of Indonesia Number 9 of 2019). The following is a photo documentation of Batu Mahpar Geopark Recreation Park, which can be seen in Figure 1.
