APEXIFICATION FOLLOWED BY DIRECT COMPOSITE VENEER ON ELLIS CLASS IV FRACTURE: A CASE REPORT

Effendi Halim*, Yoanita Dwiaidina*, Wignyo Hadriyanto*, Pribadi Santosa*, Ema Mulyawati*, Yulita Kristanti*

* Departemen Konservasi Fakultas Kedokteran Gigi Universitas Gadjah Mada

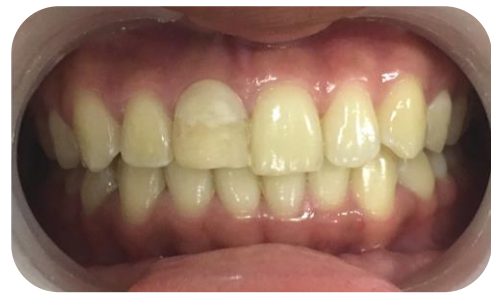
Figure 1. Clinical picture of initial condition. There was a composite filling in the half incisal of tooth 11 and internal discoloration.

Subjective and objective examinations, intraoral photographs, radiographic photographs were performed. The patient was informed about the procedures, the costs, and the time of treatment. After the patient agreed to proceed with the treatment, the patient filled out and signed an informed consent. Tooth 11 was diagnosed as 11 pulp necrosis with asymptomatic apical periodontitis, open apex, and intrinsic discoloration.

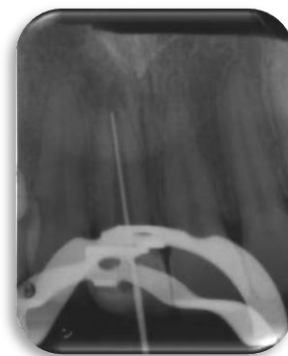
Figure 2. Radiograph measurement of working length. Confirmation with periapical radiograph showed that the working length of tooth 11 was 24 mm.

Cavity access was made using endo access burs and was expanded using non-cutting ended fissure burs. The treatment started with the measurement of the estimated working length with the help of periapical radiographs (25mm) with a 1 mm reduction (compensation for radiographic distortion) to obtain an estimated working length of 24 mm. Exploration was done using smooth broach. Root canals were irrigated with 2.5% NaOCl and saline solution. The working length was measured using K-file # 50.

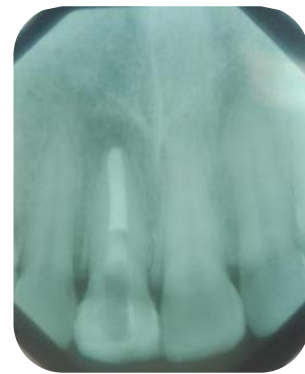
Figure 3. Periapical radiographs for MTA filling. It appears that the MTA has been filled with 4 mm long filling from the apex of tooth 11

Afterwards, mineral Trioxide Aggregate (ProRoot MTA, Dentsply) was prepared. Mineral Trioxide Aggregate powder was mixed with sterile distilled water in a mixing pad using a spatula. Once it reached a sand-like consistency, it was put into the root canal using a hand plugger. The Mineral Trioxide Aggregate was applied along one third of the root canal (4 mm) from the apex. The Mineral Trioxide Aggregate was inserted into the root canal and was compacted with a hand plugger that had been marked with a rubber to mark the expected height (4 mm from the apex). The remnants of the MTA attached to the root canal wall were cleaned with cotton pellets moistened with sterile distilled water. The cotton pellets that have been moistened with the sterile distilled water were squeezed and then put into the root canal. The cavity was closed with a temporary lift (Cavition, GC), then the rubber dam was removed. Retrieval of periapical radiographs to ensure MTA applications followed the expected height.

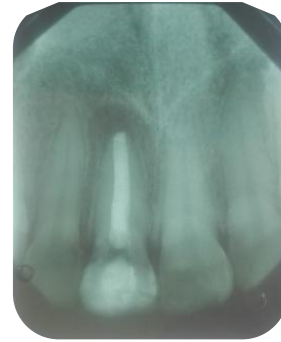
Figure 4. Radiographic appearance of tooth 11 after obturation and gutta-percha cutting, showing hermetic obturation

The obturation was performed with vertical warm obturation by inserting a resin sealer using a lentulo. The gradual obturation was performed at 2-3 mm stage thickness with the gutta-percha extruder until it reached 2 mm below the orifice. Afterwards, the vertical condensation was done with a hand plugger every 2-3 mm gutta-percha insertion. The gutta-percha was filled in the root canal up to less than 2 mm from the cervix towards the apical limit of the gingival margin. The depth of the reduction in the gutta-percha was checked using a probe. The pulp chamber was cleaned, and the dentin of the labial part of the pulp chamber was also cleaned at a low-speed bur, rinsed with distilled water, and dried. The dental conditioner was applied in the pulp chamber for 10 seconds. The pulp chamber was then washed and dried gently. The cervical barrier was made using a resin-modified glass ionomer cement of 2 mm thick above the gutta-percha, then irradiated for 20 seconds. Afterwards, periapical radiographs were taken to ascertain the thickness and location of the cervical barrier base. An examination of the root canal filling was performed by taking radiographs, and the result showed a hermetic filling.

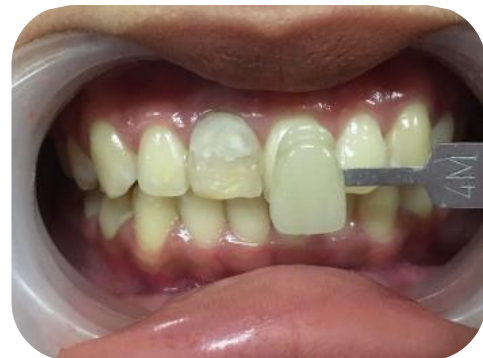
Figure 5. Clinical Picture Examination of the teeth color with 3D fit revealed that the initial color of tooth 11 was 4L2.

The subjective examination indicated no complaints (no pain between visits), and the patient wanted to continue her dental treatment according to the treatment plan as described earlier. The objective examination demonstrated that a temporary lift was still in a good condition with neither leakage nor fistula. The percussion, palpitation, and mobility showed negative (-) results. The examination of the teeth color with a 3D fit found that the initial color of tooth 11 was 4L2.

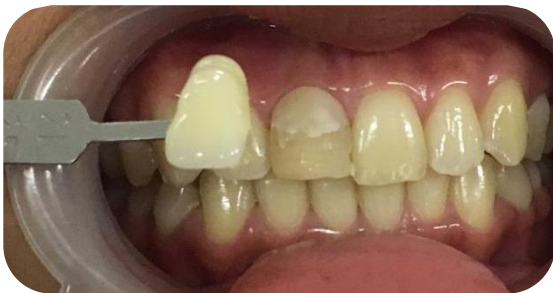
Figure 6. Clinical features of tooth 11 after application of bleaching material for 7 days showed that the discoloration of teeth was still slightly different compared to the color of the shade guide of the adjacent normal tooth.

The subjective examination indicated no complaints but the color of the tooth partially changed to that of the other teeth. The objective examination demonstrated that the temporary lift was still in a good condition with neither leakage nor fistula. The percussion, palpation, and mobility indicated negative (-) results. The re-checking of the teeth color with a 3D fit found that the color of the cervical part of the teeth had not changed much compared to the tooth next to it by using a shade guide. This result required a re-application of the bleaching material and the patient was asked to have a dental control 7 days later or if the color of the particular tooth had turned the same as that of the tooth next to it.

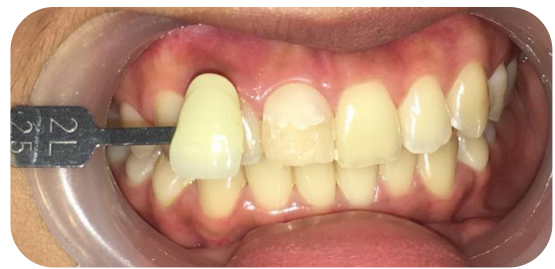
Figure 7. Clinical features of tooth 11 after application of bleaching material for the second 7 days resulted in A2 color in the cervical section with 3D fit

The subjective examination revealed no complaints but it indicated that the discolored tooth partially turned to the expected color. The objective examination demonstrated that the temporary lift was still in a good condition with neither leakage nor fistula. The percussion, palpation, and mobility indicated negative (-) results. The re-checking of the teeth color with a 3D fit showed that the color of the cervical teeth had changed to 2L2.5.

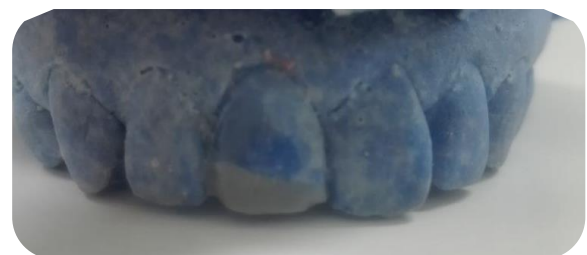
Figure 8. Clinical features of dental mock up 11.

The temporary filling was dismantled and the bleaching material was removed. The cavity was washed with warm water. Then, a calcium hydroxide paste was given to balance the pH. The cavity was closed to the temporary lift. The working model of the mock-up was created by printing. Therefore, a palatal guide was printed using elastomeric printing material filled with a blue cast stone. The patient was asked to come seven days later for the restoration.

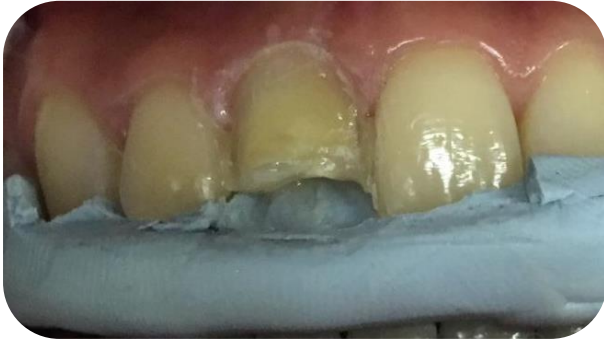
Figure 9. Palatal guide installation

The bulk fill flow composite resin (SDR, Dentsply) was applied for the intracoronal parts and irradiated with a light-curing unit for 20 seconds. The palatal guide was installed to restore the palatal area, after determining the restoration limit on the palatal section to allow no excessive application of the composite resin material on the palatal part. The palatal guide was marked by sharp instruments like a sonde.

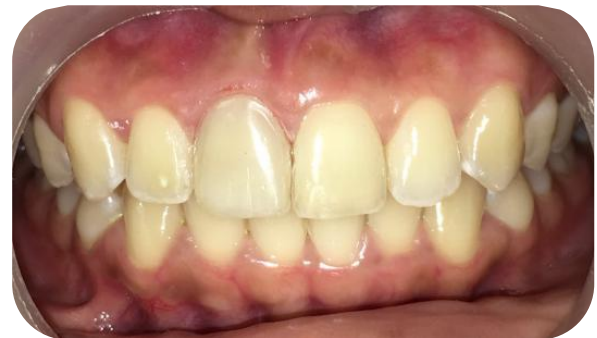
Figure 11. Restoration of tooth 11 after finishing and polishing

Occlusion was checked with an articulating paper. The traumatic part next to the palatal was reduced by the peer shaped finishing of the yellow ribbon bur. Furthermore, the packable composite resin (Premisa, Kerr) A2 color enamel was used. The developmental groove in the labial section was formed by tapered fissure finishing with a long bur. Afterwards, the finishing was done using aluminium oxide-coated rotary abrasive disc (Soflex, 3M) starting from a coarse and medium roughness level with a slow rotation, then a fine and superfine level with a tight rotation. The composite resin was polished using a diamond-impregnated polishing disk (Eve computed) of superfine roughness.
