Characteristics Slum and Squatter on Waterfront at Pejagalan District, North Jakarta

Risyal Rasyid¹, Arya Ipaldi² dan Mila Karmilah³

Sultan Agung Islamic University, Urban and Regional Planning Engineering
Jl. Raya Kaligawe Km.04, Semarang, Jawa Tengah, Indonesia
Email: karmilahmila@gmail.com

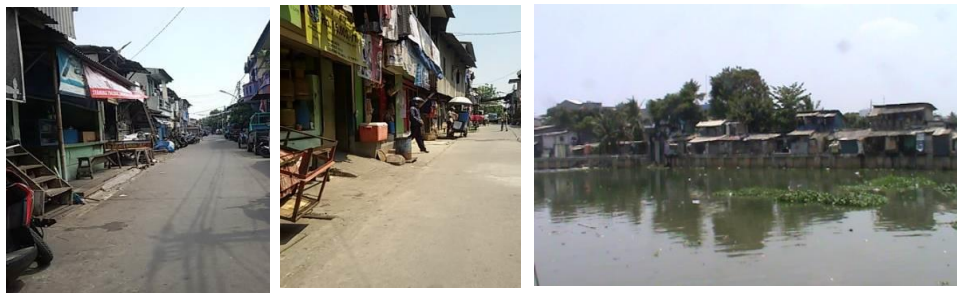
Figure 3. Building Condition

Most houses in the form of a regular house. Generally a simple building, semi-permanent, and uninhabitable. Based on observations at the site of ± 60 % of the houses are uninhabitable, especially homes that are on the edge of the river, with the condition of perishable construction materials and emergency memorable.

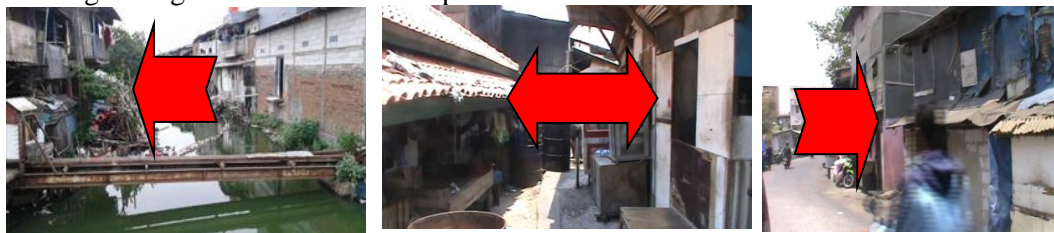
Figure 4. Building Density Level

The growing of housing development tend to unplanned, develop according to the needs of owners, regardless of the distance between the buildings , the distance between the neighboring house and the street pattern.

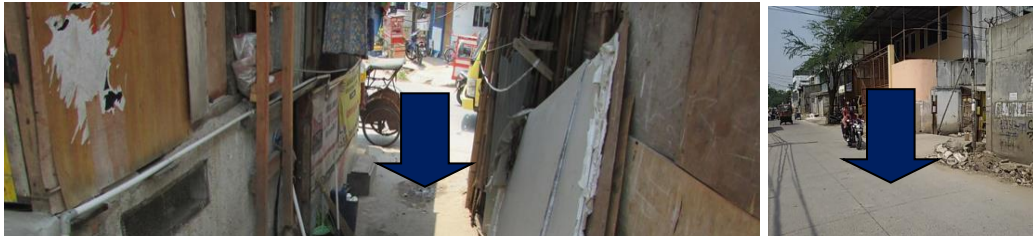
Figure 5. Road condition

There is a 90 % neighborhood streets and footpaths have good conditions and only 10 % of land which has not been served path , with pattern street layout and the housing has not been arranged well . Thus this condition is categorized as slums , because there is only 10 % of the land unserved road .

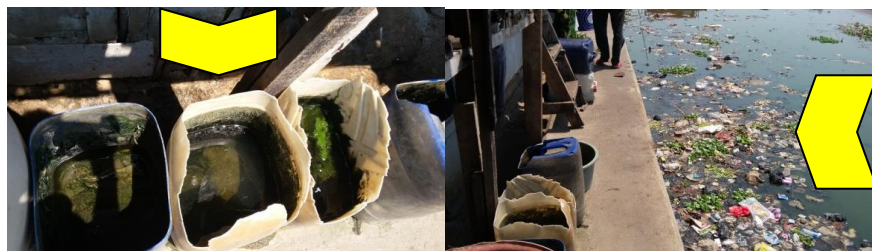
Figure 6. Water Supply condition

Service Level Water supply in Pejagalan district most of the population has clean water from the channel PAM (70 %), especially those living on the ground, At certain locations can still be obtained water from dug wells, but the water quality is poor due to the absorption of water from the river, so that can only be used for toilet function. Under these conditions there are approximately 30 % of the population that is not served with clean water, so it can be categorized as mild rundown.

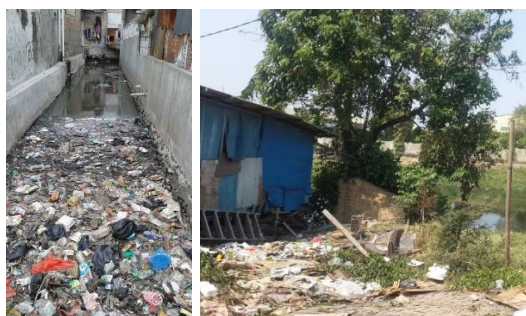
Figure 7. Garbage condition

In general Pejagalan district residents throw the garbage are in the river (90.9 %) and the rest burning their garbage (9.1 %) in the yard or in open places. The absence of transport fleet of garbage and landfills while adequate cause of more people choose the easy way to do and places their garbage within easy reach. From dispose of garbage population, this condition can be categorized as very seedy, because more than 70 % of the population dispose of waste in a place that is not its designation, which is on a river and open.
