## Pedestrian Way Assets Performance Analysis Based on Pedestrian Level of Service (PLOS) In Lembang Street Segment

Tiafahmi Angestiwi,<sup>1\*</sup> Sabila Masturah<sup>1</sup>

<sup>1</sup> Asset Management Study Program, Department of Business Administration, Politeknik Negeri Bandung, Indonesia

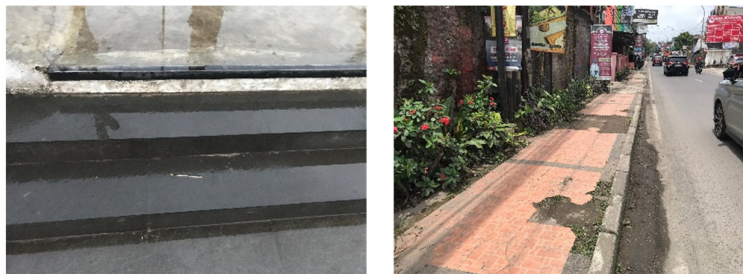
**Figure 4.** Pedestrian Way Surface along Lembang Street Segment

These findings are consistent with previous studies that highlight the inadequacy of pedestrian infrastructure in many urban areas. Similar to the observations along Lembang Street, Darmawan et al (2024) found that the physical presence of sidewalks does not necessarily reflect their functionality, as many are in poor condition and fail to meet safety standards. Likewise, Mauliani et al (2015) emphasize that insufficient width and discontinuity of pedestrian paths significantly reduce accessibility and usability. Furthermore, Prattyni (2024) also identifies that damaged pavement conditions such as cracks, uneven surfaces, and missing segments pose serious safety risks for pedestrians. However, compared to these studies, the condition observed in the Lembang Street segments indicates a more critical level

of deterioration, particularly due to the combination of structural damage and the complete absence of sidewalks in certain areas.

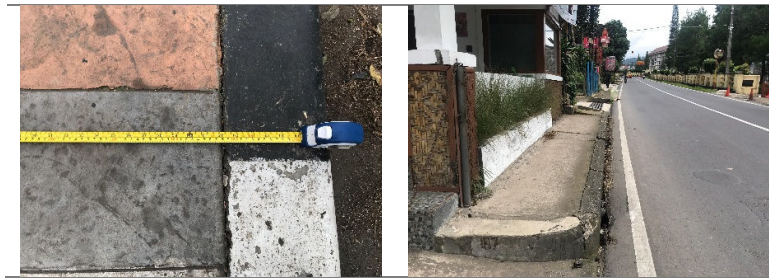
**Figure 5.** Pedestrian Way Width along Lembang Street Segment

A major issue identified is the insufficient effective width of the sidewalks. While visually some sidewalks may appear wide, the usable walking space is largely obstructed by large trees, utility poles, advertisement boards, and open drainage channels. These obstacles significantly restrict pedestrian movement, often forcing people to walk in single file or step onto the streetway when passing one another.

From a safety perspective, there are no bollards or physical barriers to protect pedestrians from motorized traffic. As a result, sidewalks are often misused as parking space for motorcycles and cars, especially near public facilities such as minimarkets, restaurants, and commercial stores. This absence of protective elements also affects other dimensions such as *Encroachment on Footpath* and *Pedestrian Traffic Interaction*, as there are no physical safeguards to prevent conflicts between pedestrians and vehicles.

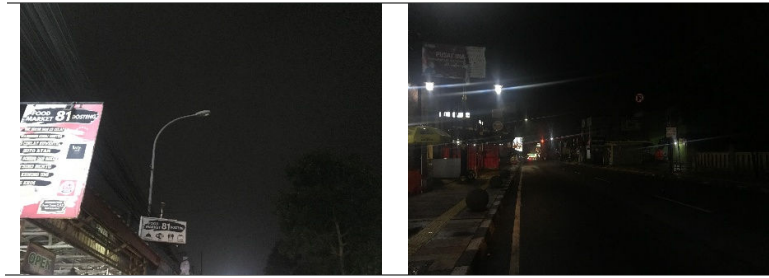
**Figure 6.** Night Lamp along Lembang Street Segment

Observations revealed that lighting conditions along many segments of the pedestrian walkway are extremely inadequate. Numerous areas lacked public street lighting, while others had dim or poorly distributed lights that failed to illuminate the pedestrian surface properly.

This severely compromises pedestrian safety, especially where uneven or damaged pavement exists, and is further exacerbated during the rainy season.

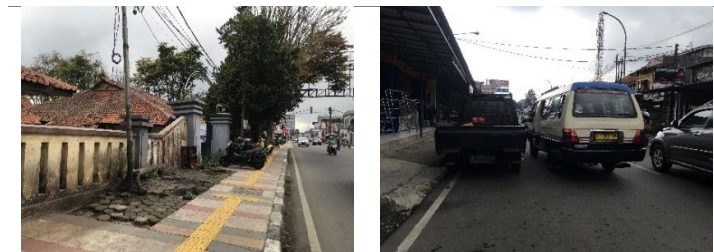
**Figure 7.** Parked Vehicle along Lembang Street Segment

Observational data indicate that numerous sections of the footpath are frequently occupied by parked motorcycles and cars, especially near commercial zones and public services. Additionally, informal street vendors often establish stalls on sidewalks, severely limiting the usable space for pedestrians. In many cases, the effective width of the footpath is reduced to less than one meter, forcing pedestrians to walk on the streetway, thereby increasing the risk of traffic accidents.
