## **Retrofitting of Reinforced Concrete Beams Using a Fiberglass Jacketing System**

**Abstract:** Building collapse that occurred mostly caused by structure failure in containment earthquake load. Factors that lead to the failure of the beam, among others is beam planning that does not calculate ductility or restraint, resulting decline of beams performance. One way to improve beam strength and ductility are to retrofit the beam by wrapping beams using fiberglass. Research aims to discover the increase amount of bending load capacity from concrete beam that has been retrofitted using jacketing fiberglass. Experimental testing was carried out on beam specimens with a cross section size of 150x200 mm and a length of 1400 mm. Three beam specimens were subjected to bending loads with a three point loading system, with different levels of damage, namely BL1 with collapse at level-1, BL2 at level-2, and BL0 at level-5 as a comparison. Then the BL1 and BL2 were retrofitted by being coated with 2 layers of fiberglass which were glued using epoxy resin. Beams BL-1 and BL-2 are then subjected to a bending test again until they reach level-5 collapse. The test results showed that retrofitte

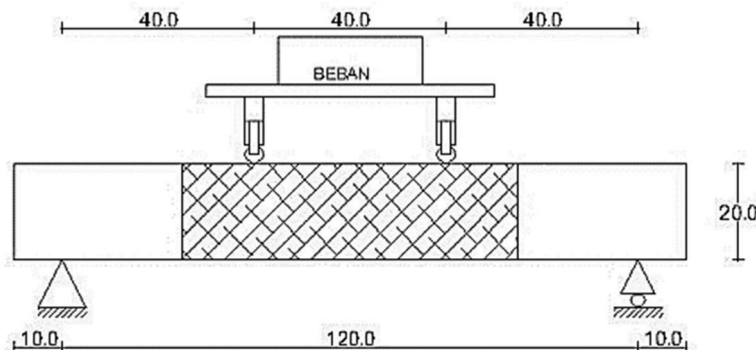
Fiberglass jacketing is carried out after the test object is loaded and collapsed according to plan. The fiberglass is wrapped in 2 layers of blocks using epoxy resin.

**Fig. 6.** Jacketing beam using WR400 fiberglass

Retrofitting was carried out on BL1 and BL2 beams by means of 2 layers of woven roving fiberglass jacketing CWR-400 using epoxy resin as adhesive.

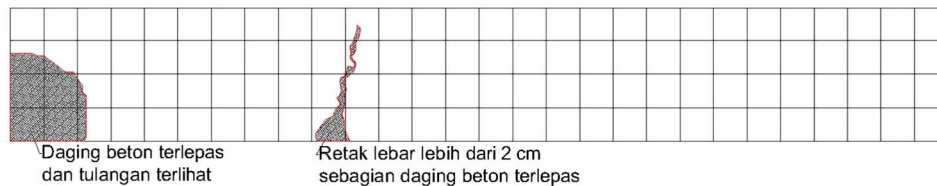
a. crack pattern at first loading

b. crack pattern at second loading

Fig. 8. comparison of beam crack pattern of BL1 and BLR1

BLR1 beam is retrofitted BL1 beam. BLR1 collapse beam flexural and shear failure simultaneously where properties differ collapse during the first loading only collapse bending. Shear failure can be seen because there is a large crack on the outer side of the beam which is not coated with fiberglass. The part of the fiberglass layer is not torn, instead the layer is debonded or the bond between the fiberglass layer and the concrete surface is released. Debonding can be seen because the fiberglass layer swells in the area that is experiencing cracks.
